G-IV-C-179

Shallmar Survey District
Shallmar
Multiple, private

State Historic Sites Inventory Form

historic Shallmar Survey District

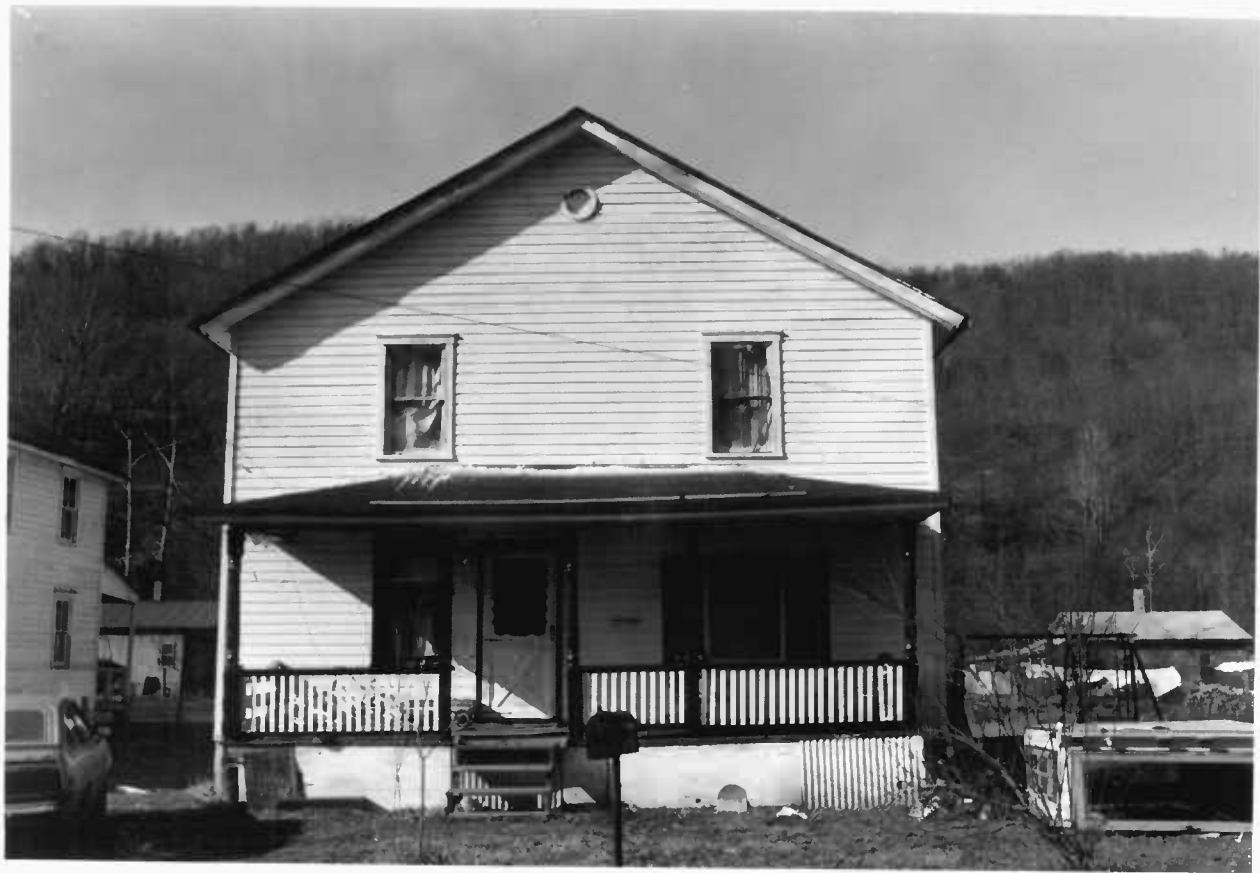
House #18

East elevation

Houses #17-19 and #22 are all that remain of a considerable number of duplex houses which once stood in Shallmar. Each is two stories tall and four bays wide with German siding and a one story porch supported by turned posts. Two doors are placed close together in the middle of the gable end facade. A decorative ventilator similar to that which appears on other houses in Shallmar is placed in the center of the gable. Each side elevation has between eight and ten windows with two-over-two sashes. The porch on #19 has an unusual slat balustrade, but otherwise these duplexes appear quite similar. Most have acquired various additions to the rear.

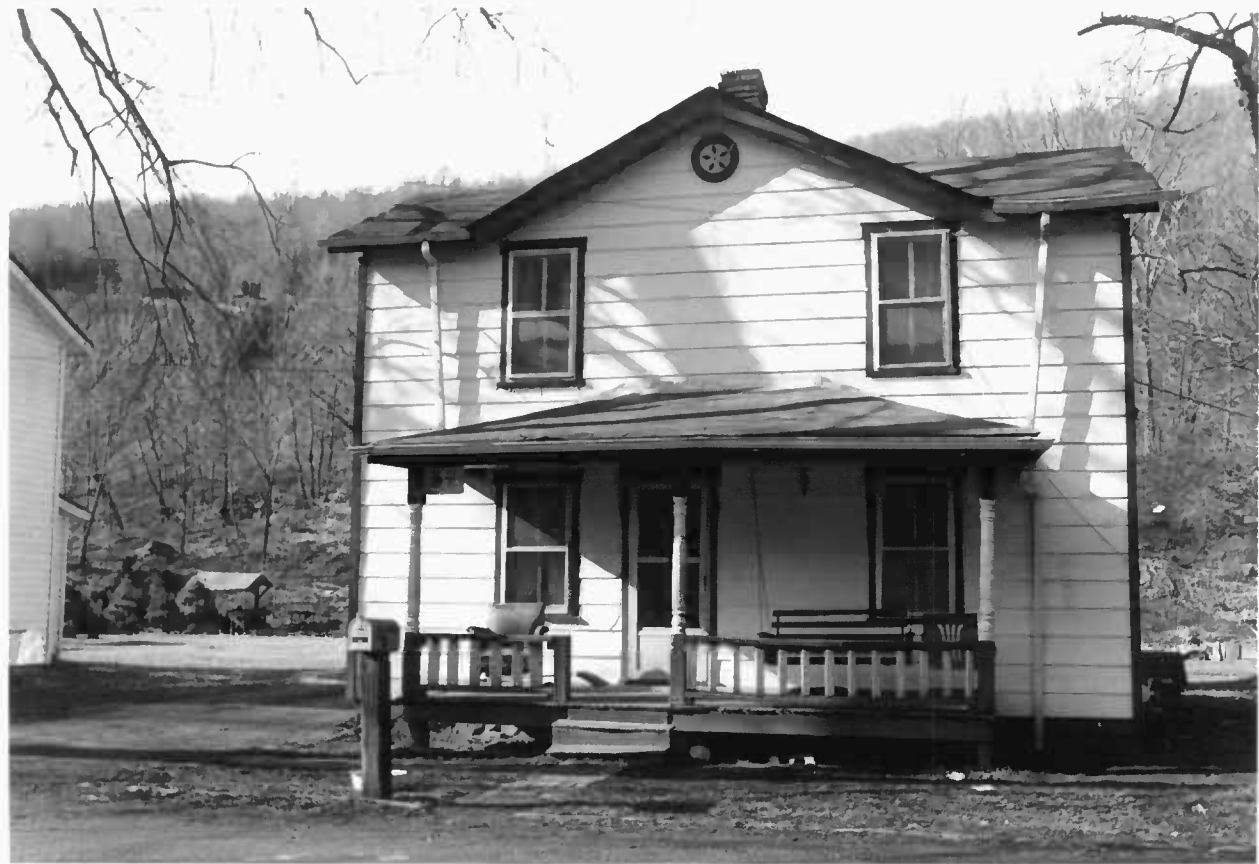
House #9

East facade

There are four distinct types of houses in Shallmar. Most typical is the two story, three bay wide frame house of stud construction with central door and front porch. Houses 6-11, 23-25, and 33-44 conform to this type, and the stretch of houses along Shallmar Road between 33-44 present a particular uniform appearance.

Distinguishing characteristics of this type include the front porch supported by three turned posts, a cross gable set in the center of the long side of the gable roof, a jig sawn round ventilator in the middle of this cross gable (virtually the only decorative touch to these houses), a simple cornice above each window and door and a central chimney with corbelled cap. House #35 retains an original front door with five raised horizontal panels.

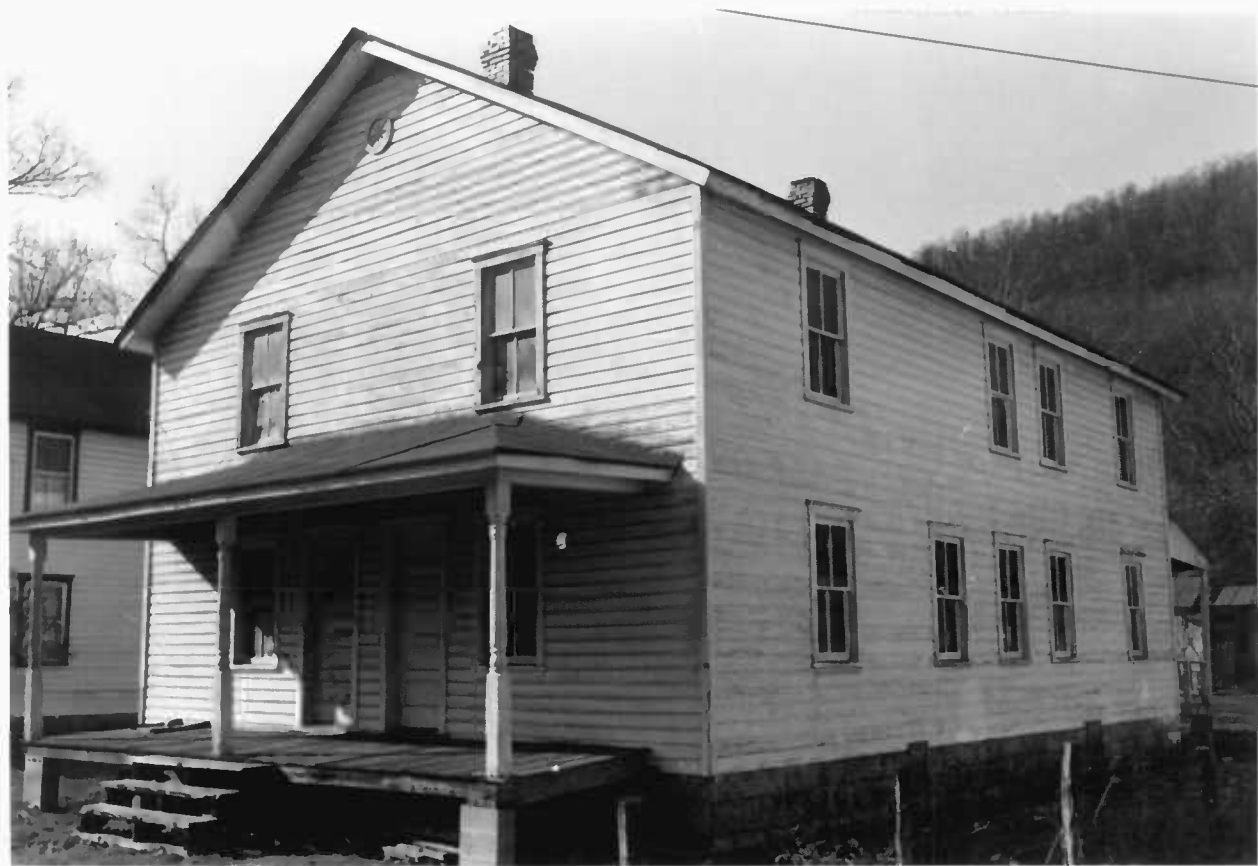
Shallmar Survey District
Garrett County, Maryland
House #18
NE Corner
G. Henry 1/83

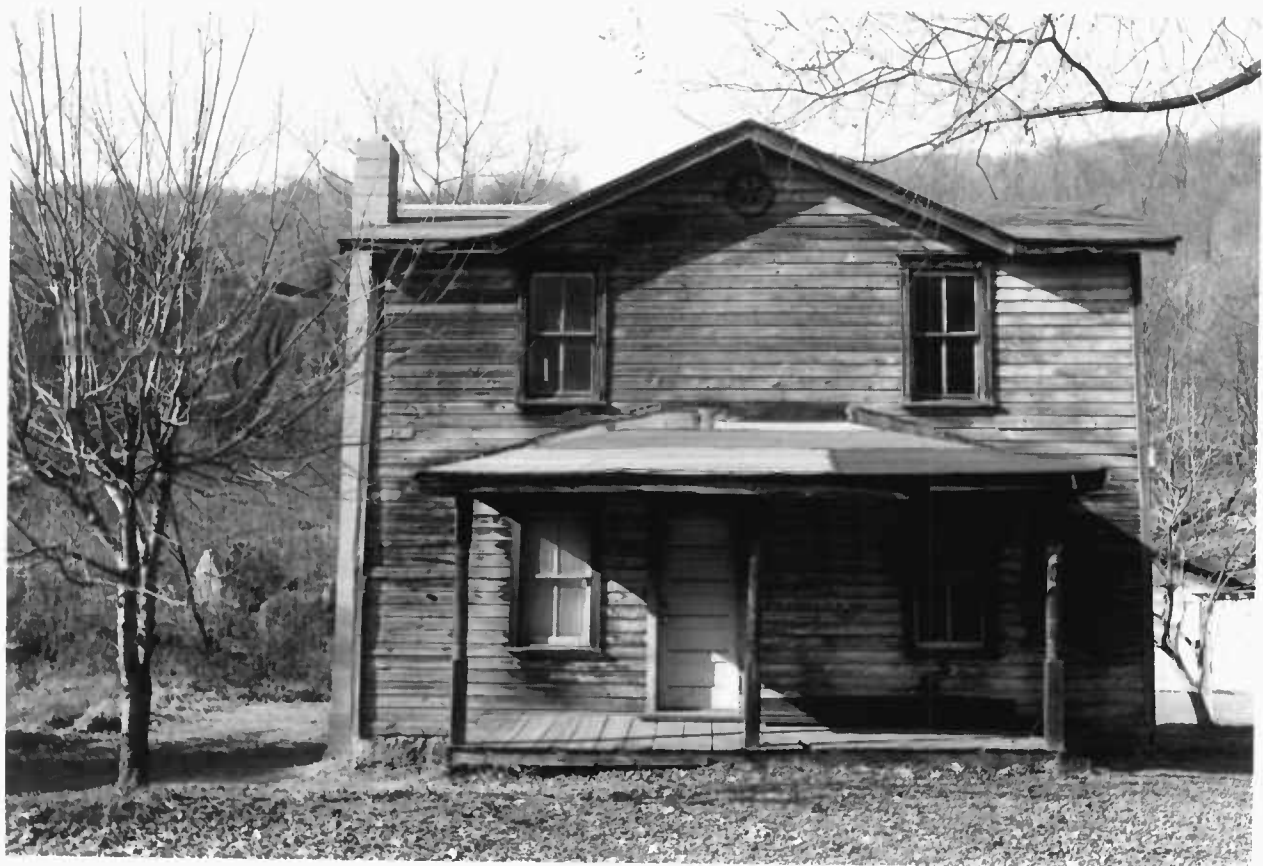
House #35

East facade

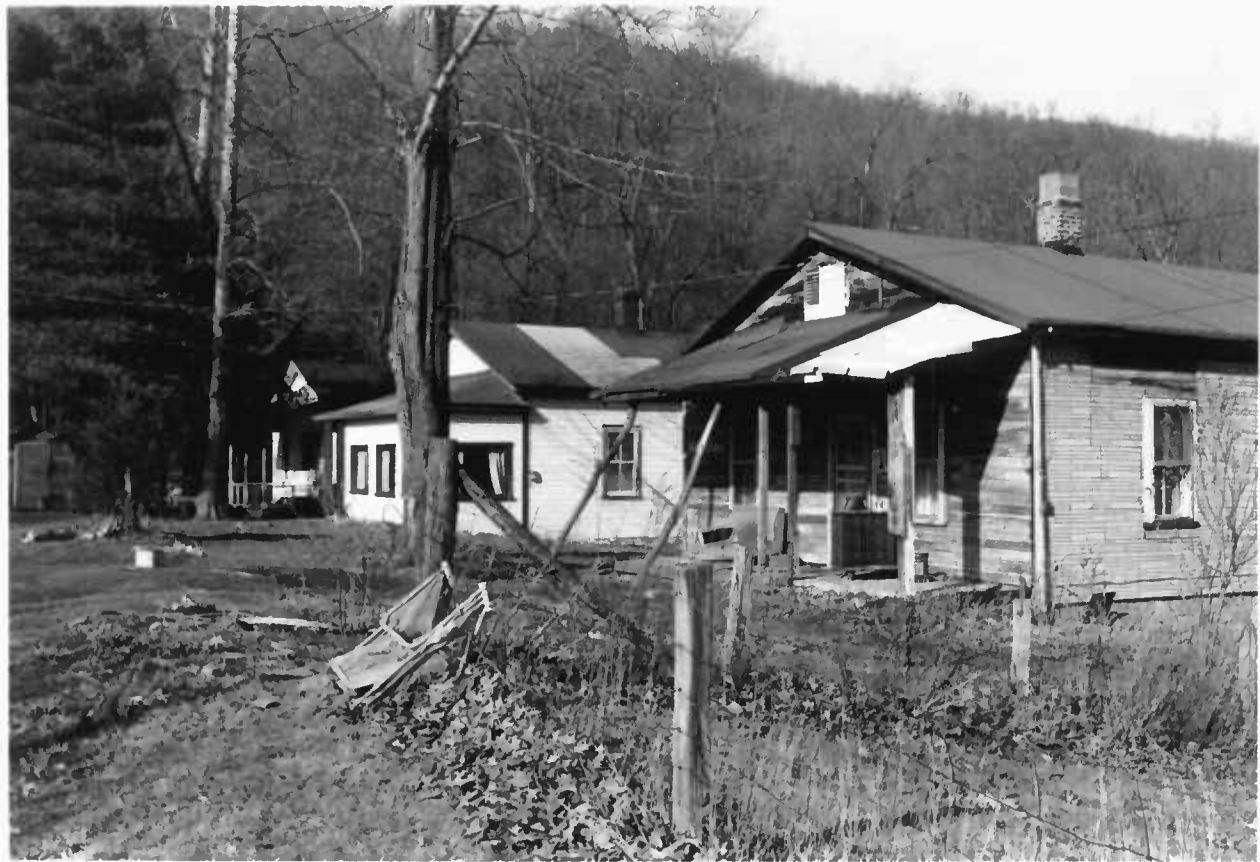
Shallmar Survey District
Garrett County, Maryland
Houses #16, 15, 14
looking west
G. Henry 1/83

Facing the athletic field are three houses (#14-16) of a type once quite numerous in Shallmar. Each is 1½ stories with a gable end entrance. A shed roof porch supported by turned posts extends along the front of the house, the one at #15 being recently enclosed. All three are three bays deep with a small porch at the rear. These houses are considerably smaller in scale than the single family houses along Shallmar road.

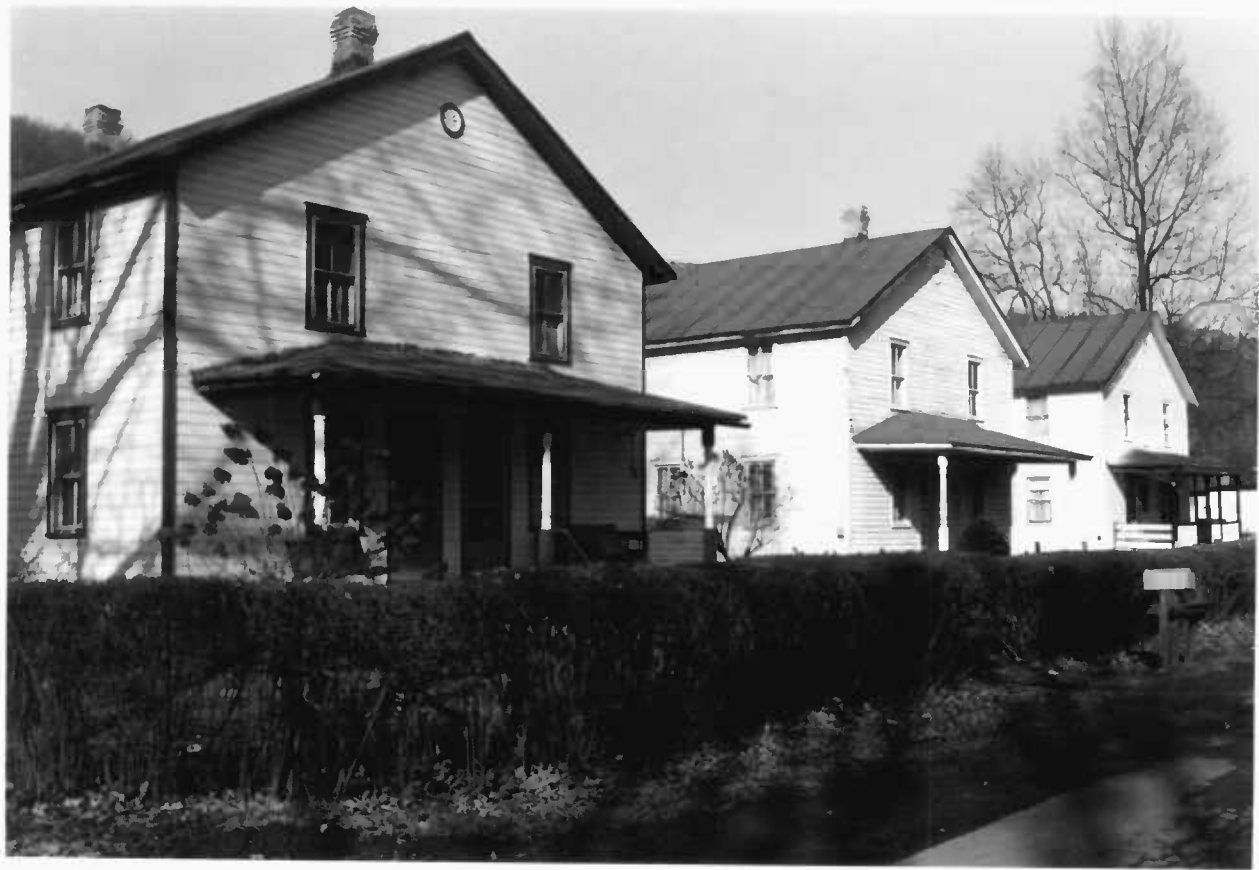
Houses #17, 18, 19

looking NW

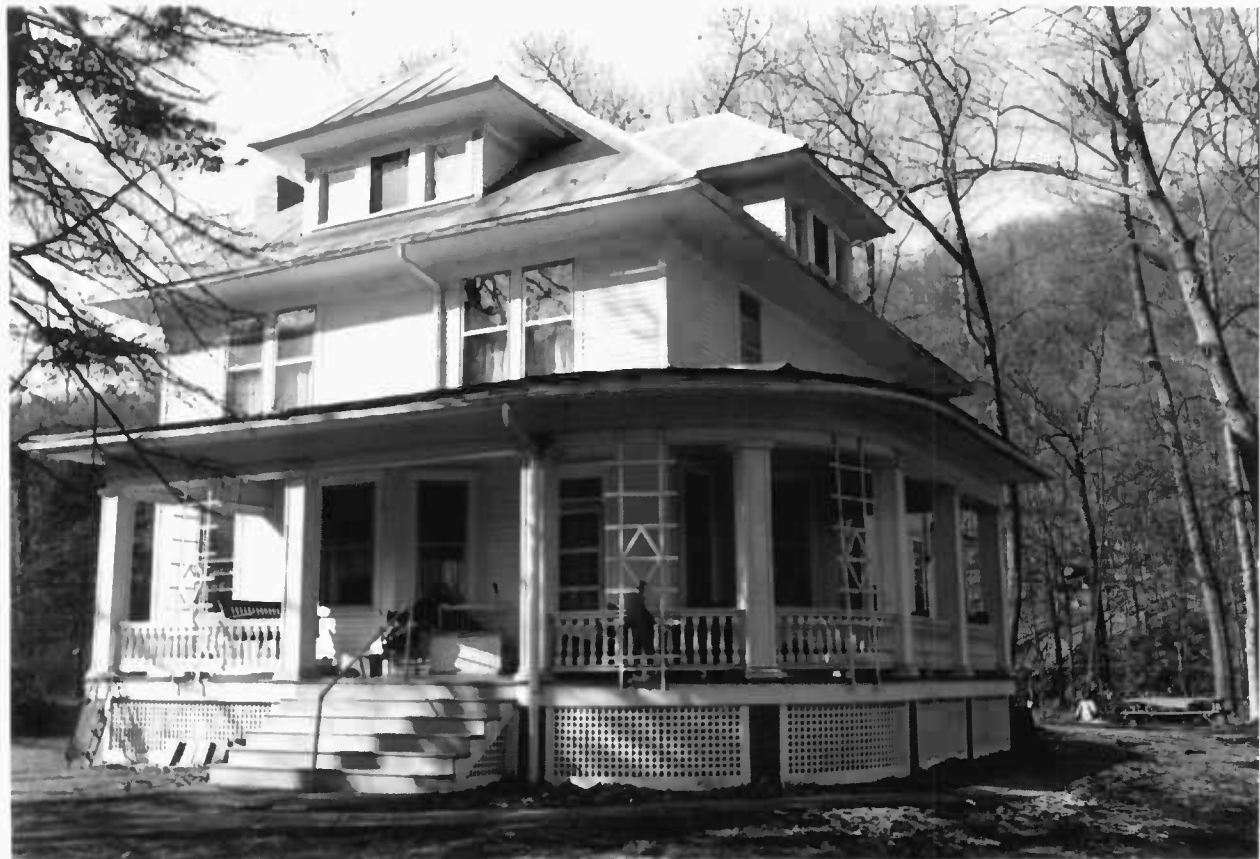
House #12

Oblique NE view

The house at #12, a late Queen Anne style building, is the largest in Shallmar, and was built to house the Superintendant. This large, two-and-one-half story, three bay wide frame house has an off-center front door reached by wide steps. The most outstanding feature of this house is the one story wrap-around porch which extends from the front part way around the north side of the house. A row of turned balusters runs between the square panelled Doric columns which support the porch. A hipped dormer with triple windows sits on both the north and east sides of the roof. Two large shed-garages stand twenty feet to the north of the house.

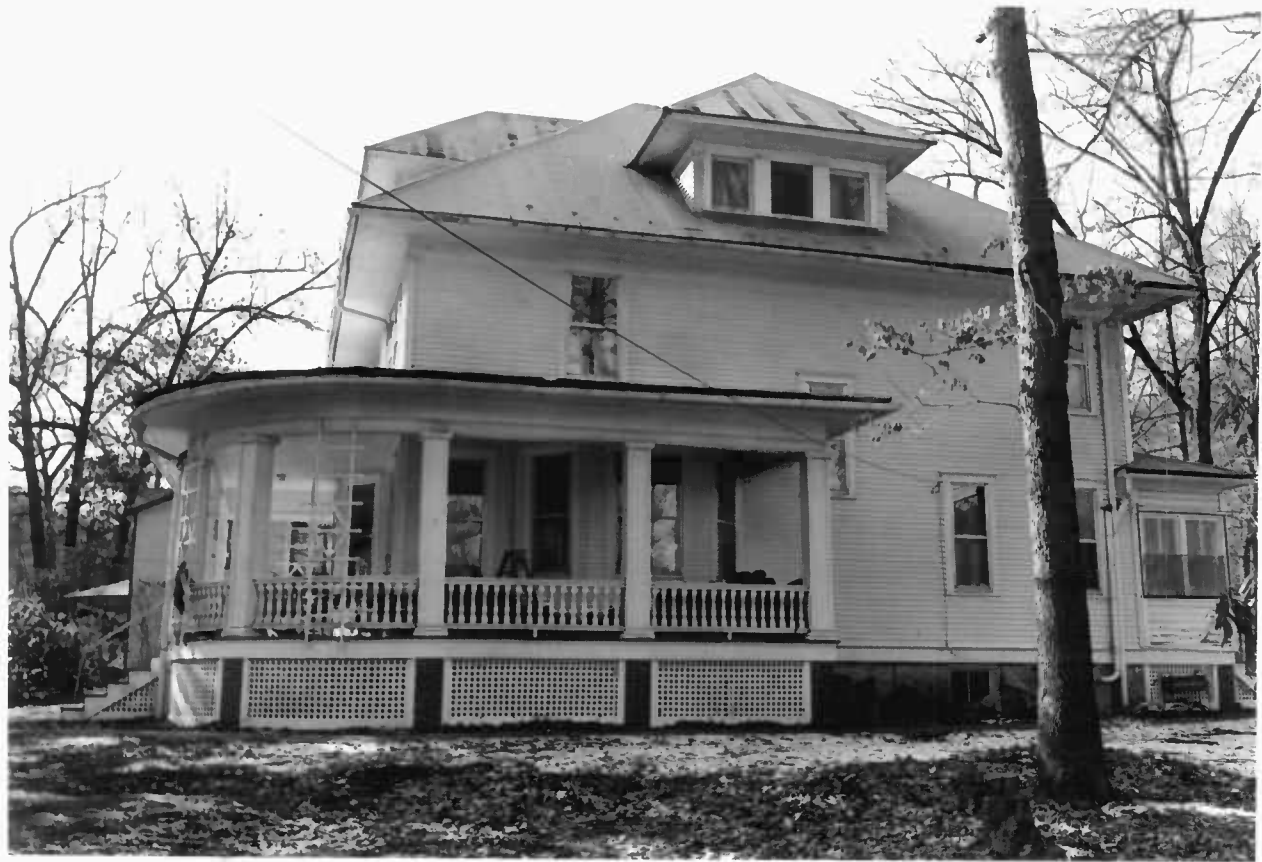
House #12

North elevation

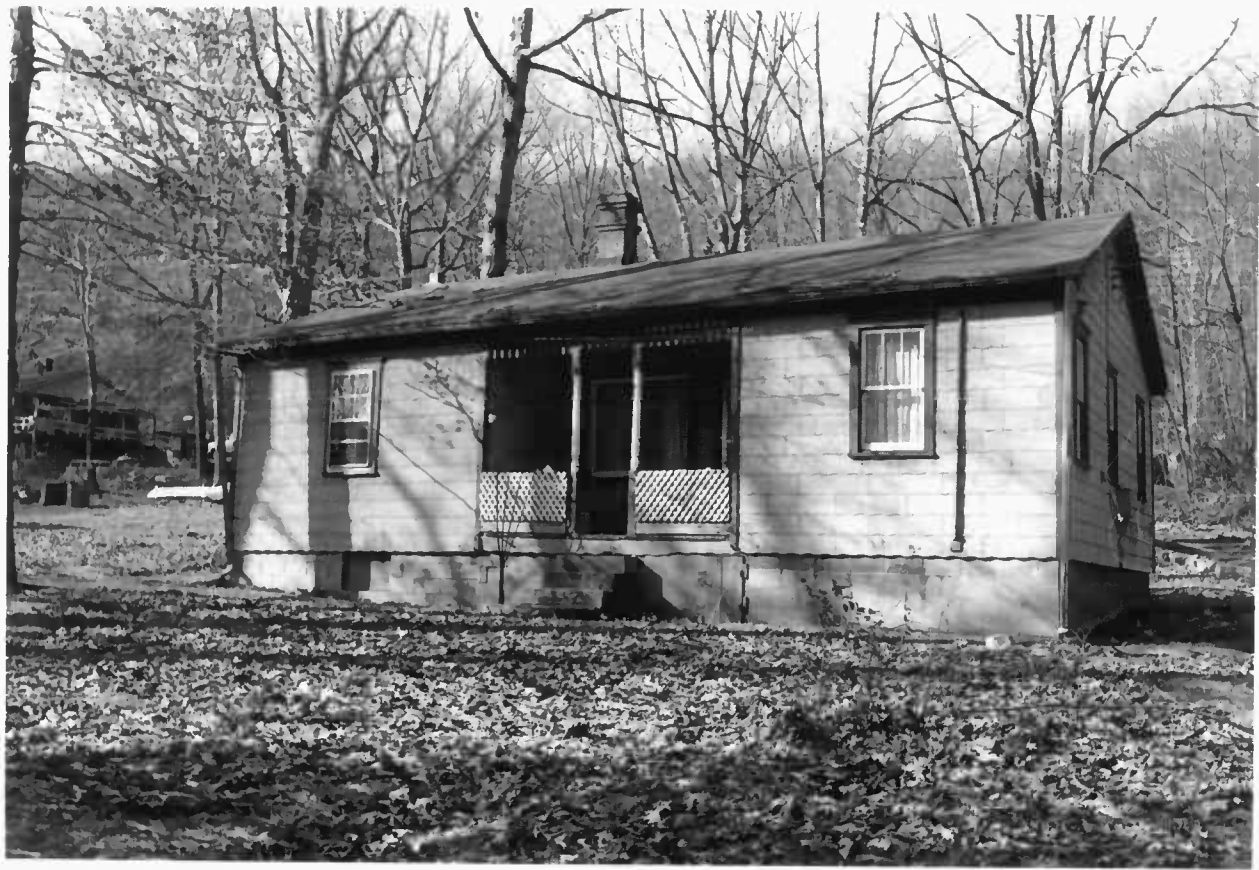
Shallmar Survey District
Garrett County, Maryland
House #26
East facade
G. Henry 1/83

Road makes a slight bend. House #26 is the most typical of these houses and has undergone the least alteration. It is a one story, four bay frame building with a recessed porch and entry. At the rear of the three bay deep house is a small shed roofed porch. House #28 is raised on high foundations and has a side porch but is otherwise similar in appearance to both #26 and 27. House #29 is a modern non-contributing house.

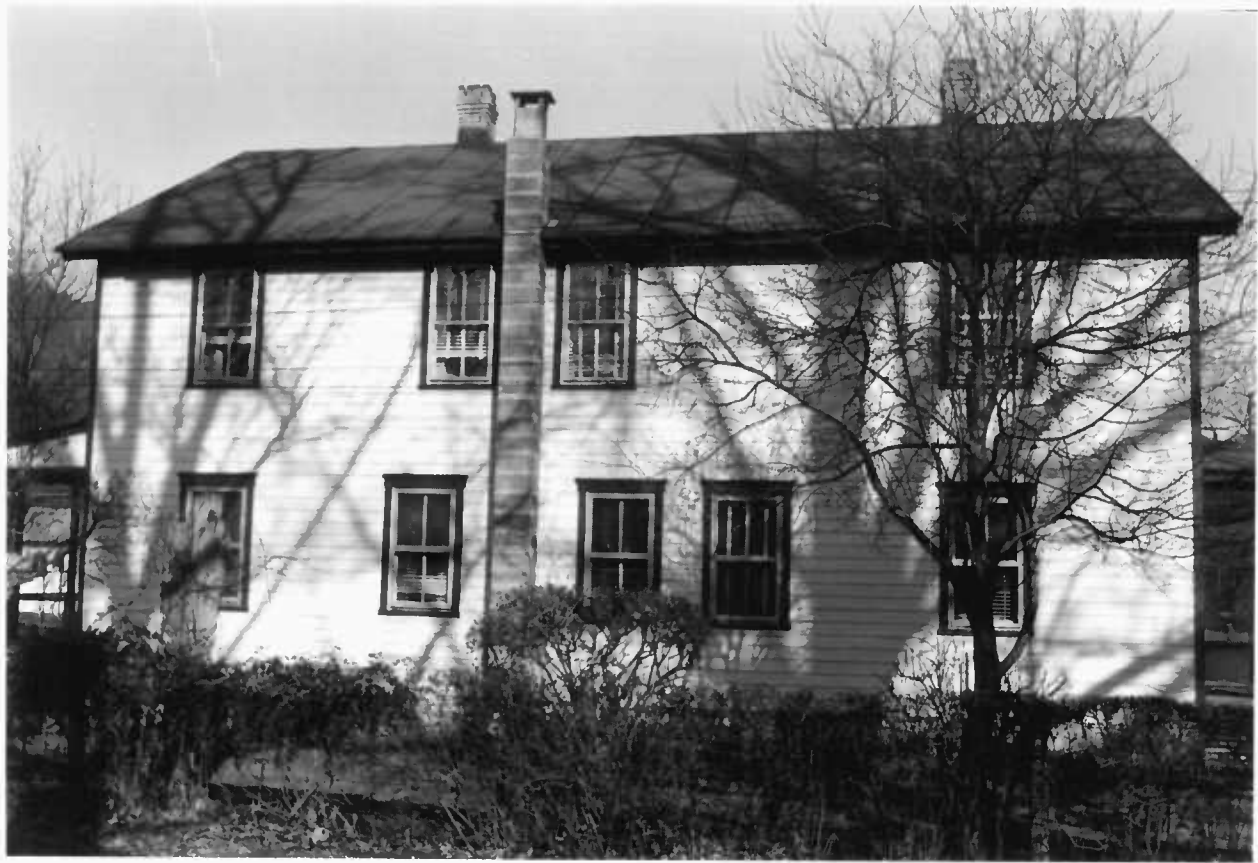
Shallmar Survey District
Garrett County, Maryland
House #17
South facade
G. Henry 1/83
